On the Trap Assisted Stress Induced Safe Operating Area Limits of AlGaN/GaN HEMTs

Abstract—**This experimental study reports a systematic investigation of Safe Operating Area limits in AlGaN/GaN HEMT using sub-µs pulse characterization with on the fly Raman and CV characterization to probe defect and stress evolution across the device. Influence of a recess depth on SOA boundary is analyzed. Post failure analysis corroborates well with the failure physics unveiled in this work.**

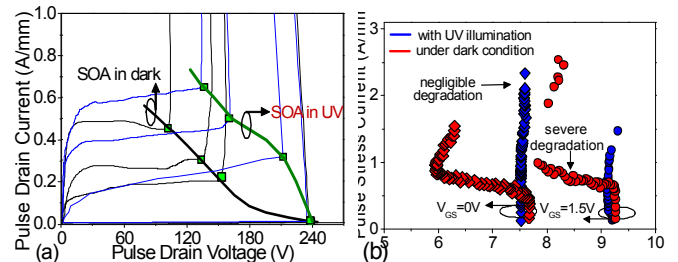
To understand, the physics of SOA improvement with UV, in further detail, a HEMT structure was simulated in TCAD at different buffer trap concentrations. And the electric field distribution in channel was extracted in each case as shown in Fig. 3(c). It revealed that the peak electric field in the channel shifts from gate to drain edge in presence of buffer traps, which is equivalent to the case of I-V measurements done under dark. In absence of traps the electric field peaks at the gate edge which occurs when the UV exposure was present while stressing the device. Therefore, traps can modify the field distribution and hereby potentially govern the device degradation via field driven mechanisms like inverse piezoelectric effect and influence the SOA boundary of AlGaN/GaN HEMTs. Here, effect of surface states is not studied, as the devices used in this study were passivated.

Figure 3. (a) Safe Operating Area of AlGaN/GaN HEMT under dark and UV condition. Figure highlights the trapping limits SOA boundary. (b) Comparison of degradation in linear drain current measured after each stress pulse, under dark and UV conditions. UV illumination effectively suppresses degradation by assisting in the carrier de-trapping.

(c) Simulated electric field profile in channel, with and w/o buffer traps shows peak electric field shifts from gate to drain edge in presence of traps, which is the case of test done in dark.

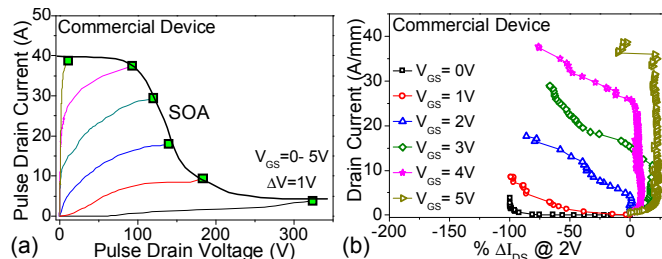
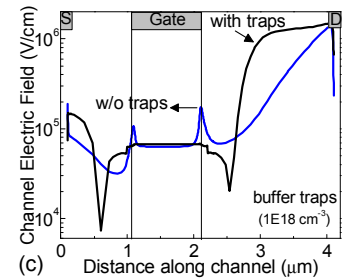
Initially, a commercial p-GaN gate E-mode HEMT was characterized to determine its SOA boundary. Figure 2(a) shows the pulse I-V characteristics with SOA. The associated degradation in spot measured drain current, under high field and high current stress conditions is depicted in Fig. 2(b). As seen, the device degraded to different extent at different gate bias, with maximum degradation in OFF-state. These results depict the importance of this study and highlight the universal nature of degradation trends presented in this work. Next, pulse I-V characterization of fabricated device was done under dark and with UV exposure, to independently determine impact of traps and self-heating on the SOA boundary as shown in Fig. 3(a). Significant improvement in SOA was observed with UV exposure, which signifies the hidden role of surface and/or buffer traps on SOA reliability. A comparison of drain current degradation trends captured in dark and UV condition, is presented in Fig. 3(b). It reveals, negligible degradation in presence of UV whereas the drain current faced significant degradation in dark. And the same observation persists at different gate bias. Possibly, UV exposure de-traps the carries trapped at different locations in the device, and mitigates the device degradation.

Figure 2. (a) Pulse IV characteristics of a commercial GaN device with SOA boundary marked. (b) Percentage change in linear drain current measured after each voltage pulse, at 2V dc. Severe degradation is observed at different gate bias with highest degradation (~100 %) under OFF-state.

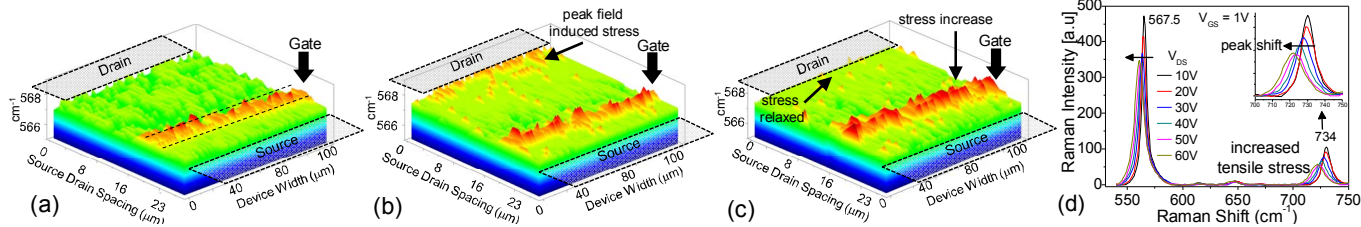
to drain region was recorded using on the fly Raman spectroscopy at regular intervals during the stress. Figure 4(a) shows the Raman map recorded in the pristine device, before stress that is under zero bias condition. It unveils the presence of high compressive stress under the gate finger. Then the device is stressed in OFF-state, under dark condition and the corresponding stress map is shown in Fig. 4(b). It reveals that compressive stress builds up at the drain edge and in drift region, under the dark condition. On the other hand, with UV illumination compressive stress was missing in the drain and drift region, and it was present only under the gate as depicted in Fig. 4(c). This result corroborates well with observation of trap induced field shift in GaN HEMT. Compressive stress develops at the drain edge due to excessive trapping, which shifts the peak electric field from gate to drain edge. UV exposure de-trapped the carriers and restored the peak stress to the gate finger. When the device is stressed under ON state, Raman peaks for GaN; E_{2-H} (567.5 cm^{-1}) and A_{0-L} (735 cm^{-1}), shift towards left with increasing stress at the drain as depicted in Fig. 4(d). This unveils that the tensile stress at the gate edge towards drain, increases with drain voltage. The increased mechanical stress creates defects/cracks in gate/drift region when its elastic energy hits a critical value [17]. DC I-V and C-V measurement were done at regular intervals during the test. Trap density was extracted in gate, gate-source and gate-drain regions at different stress levels. Figure 5(a) shows the variation in trap density in various regions of the device. A significant increase in trap density is noticed in the gate-drain region [9] with increasing drain stress. Here gate-to-drain trap density increases at a much higher rate than in the gate-to-source region. This is attributed to the piezoelectric stress developed in gate-drain region which generates new defects as discussed above. Moreover, a positive V_{TH} shift is observed with stress, as depicted in Fig. 5(b) and it points to accumulation of negative charge underneath gate via electron trapping. Also, the increased device R_{ON} and degraded drain current, point to electron trapping in gate-drain region.

Figure 4. (a) Raman map captured in source-drain region of pristine device, before stress. Figure reveals compressive stress under gate finger possibly due to gate recess. On the fly Raman map was captured during OFF-state stress (V_{DS} 60V@ V_{GS} -6V) (b) in dark and (c) with UV illumination on device. Figure (b) shows stress accumulates at drain edge when device is tested under dark condition, while stress builds up at gate edge with UV exposure as shown in (c). In dark, trapping in buffer and barrier region, causes peak electric field to shift to drain edge as seen in simulation result (Fig. 3c). UV exposure, suppressed trapping by de-trapping carriers and restored the peak field back to gate edge as evident from increased stress at gate under UV in Fig.(c). Fig.(d) shows Raman spectra spot measured, under ON-state, at gate edge towards drain at different drain stress. Left shifting in $E_2(H)$ (567.5 cm^{-1}) and $A_1(LO)$ (730cm^{-1}) Raman peaks of GaN reveal increased tensile stress at gate edge with increase in drain voltage.

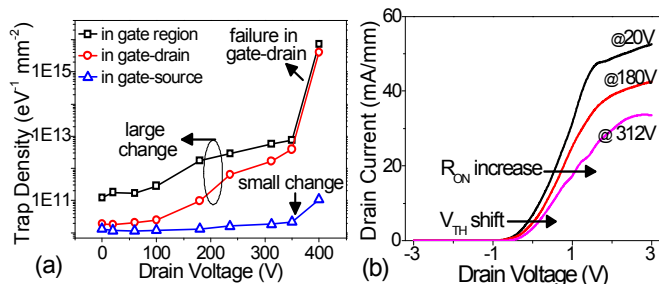
Figure 5. (a) Increase in trap density captured after each stress voltage pulse. Rapid increase in trap density in gate-drain region can be seen. (b) Transfer characteristics of HEMT recorded at regular intervals during the test shows shift in threshold voltage and increase in R_{ON} with increase in drain stress.

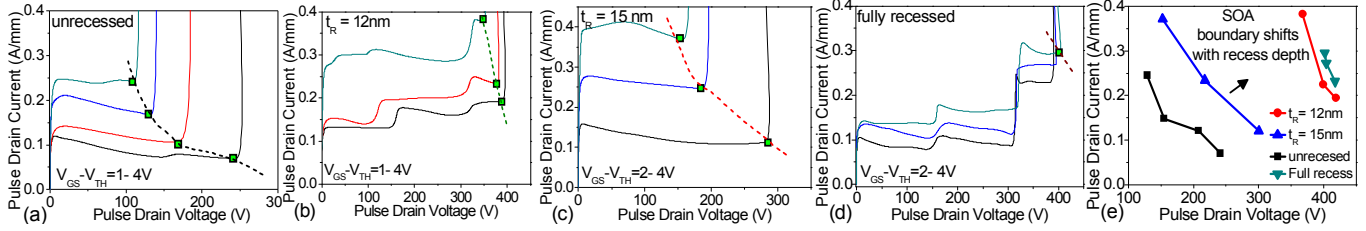
Devices with different recess depth were characterized to determine their SOA boundary as shown in Fig. 6(a)-(d). Device without gate recess exhibited a narrower SOA as depicted in Fig. 6(a), while in devices with full recessed gate, the failure occurred at a fixed drain voltage independent of applied gate bias as seen in Fig. 6(d). This reveals field limited SOA in fully recessed structure and points to a possibility of field modulation with recess depth, as discussed later. A comparative analysis of SOA boundaries of devices with different recess depth is done as in Fig. 6(e). It reveals that SOA boundary shifts with recess depth and it can be maximized using an optimum recess depth or with a partial recessed gate. To further understand it, the linear drain current was spot measured in each case. Figure 7(a) presents a comparison of distinct degradation trends in drain current as function of gate recess depth. It unveils that the percentage degradation in the device reduces with increase in recess depth. Devices without recess undergo up-to 30% degradation in drain current, while devices with 15 nm recess depth degrades only up-to 10%. On the other hand, fully recessed devices suffered from maximum degradation of 90%. To understand the underlying physics, TCAD simulation of a device was done for different gate recess depth and variation in electric field distribution in channel, is determined for different recess depths as depicted in Fig. 7(b). It shows that in case of non-recessed or fully recessed structure, the electric field peaks at either the gate or drain edge. However, for intermediate optimum recess depth, the field redistributes such that peak field gets suppressed both on gate and drain edges.

Figure 6: SOA boundary of devices with different recess depth (t_R). (a) Figures shows narrow SOA boundary in HEMT without (b)-(d) shows SOA of devices with increasing recess depth. Figure reveals that with gate recess the SOA broadens however, with fully recessed gate as in (d) device failure occurred at a fixed drain voltage independent of gate bias and reveals field limited SOA in recessed structure. (e) Shift in SOA boundary with recess depth is observed, with optimum SOA achieved with 15nm recess depth.

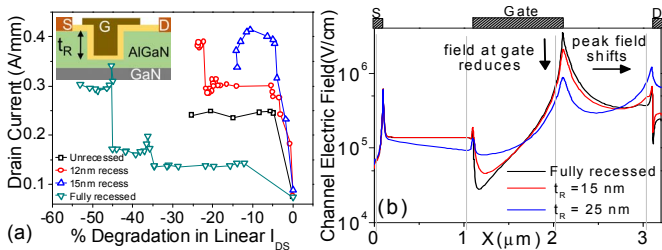
Field suppression at drain reduces impact ionization rate and avoids early avalanche in device. Low field at gate, slows the hotspot formation and hot electron induced degradation. Therefore, redistribution of channel field with suppressed peaks at optimum recess depth, improves device reliability and broadens the SOA. This explains the as observed dependence of SOA on recess depth. in this work.

Figure 7. (a) Inset shows schematic of HEMT with recessed gate where recess depth (t_R) is varied. Percentage degradation in linear drain current for devices of different recess depth, drain stressed under ON-state (V_G-V_{TH}=2V). Maximum degradation occurs in device with full recess and least occurs in device with 15nm recess depth. (b) TCAD simulation for different recess depth shows electric field peaks at gate edge in unrecessed structure. With increase in recess depth, peak field shifts to drain edge for 25nm recess depth. 15nm partial recess, suppresses peak at both gate and drain edge and improves SOA

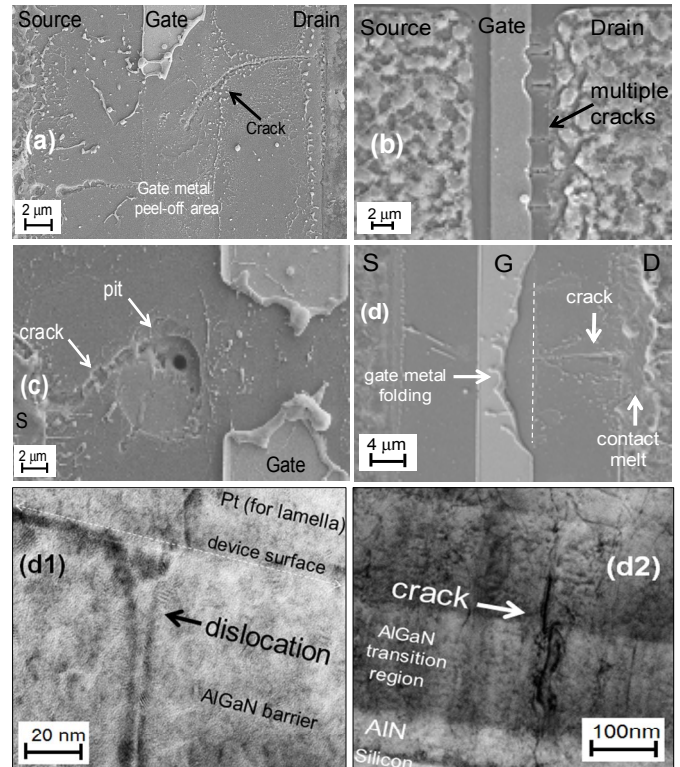
After pulse characterization, the damaged regions of failed devices were analyzed using Scanning Electron Microscopy (SEM), Energy Dispersive X-Ray Spectroscopy (EDX) and Transmission Electron Microscopy (TEM) to gain physical insight into the underlying degradation mechanism. Figure 8(a) shows the post failure SEM micrograph of a device which failed in OFF-state under UV condition. It depicts a part of gate metal finger blown-off at failure without any trace of material melting. This highlights the possibility of purely field driven failure. Presence of cracks underneath gate, towards drain side, reveal that the damage occurred due to high mechanical stress at gate edge. This observation nicely corroborates with the Raman stress map shown in Fig. 4(c) where the region under gate finger was found to be always under a compressive stress. The inverse piezoelectric effect introduces mechanical strain at gate because the channel electric field peak peaks at the gate edge in absence of carrier trapping as revealed by TCAD results in Fig 3(c). SEM image of a device which failed at a stress of 10 ns pulse duration is shown in Fig. 8(b). It unveils multiple damages formed along the gate edge in the gate-drain region. MOCVD grown AlGaN/GaN stack, possess a finite defect density which can introduce non-uniformity in carrier trapping and associated peak field shift, at drain, along the device width. Enhanced impact ionization and carrier injection into the buffer, in these localized high field regions invokes avalanche instability and causes multiple damages [9] as seen in Fig. 8(b). Figure 8(c) shows post failure SEM image of a device which faced premature breakdown under ON-condition. It reveals, presence of a pit triggered device failure in gate-source region. Pits and dislocations are native to AlGaN/GaN material system and originate from lattice mismatch between different layers. Post failure SEM image of device which was

failed under OFF-state is shown in Fig. 8(d). It shows failure occurred with a crack in gate-drain region and gate metal folding exclusively at the drain side gate edge. Metal melting/folding reveals the thermal nature of the failure. TEM cross-section was taken along the gate edge (white dotted line in Fig. 8d). It unveils the presence of a dislocation at the gate edge, as shown in Fig. 8(d1), which caused failure. The cross-sectional image in Fig. 8(d2) also reveals that the damage occurred deep in the buffer with the newly formed crack reaching till the Si substrate. This can be explained as follows; dislocations provide parasitic path for current leakage and material diffusion. This weakens the material strength via electro-chemical reactions [18] and creates local damages.

Figure 8. (a) Post failure SEM image of device failed in On-state. Figure shows cracking underneath gate blew-off the gate finger which was already under compressive stress as clear from Raman plots. (b) Multiple damages observed in gate-drain region reveal failure due to non-uniform trapping and stress distribution along device width as shown in Fig. 4a-c. Defects like pit can trigger failure as shown in (c). On-state failure in (d) occurred with crack in gate-drain region with gate metal folding. TEM cross-section taken along gate edge (white dotted line) shows presence of dislocation at gate edge, as shown in (d1) and crack in buffer reaching till Si substrate as in (d2).
