NON DESTRUCTIVE EVALUATION OF ADHESIVELY BONDED CARBON FIBER REINFORCED COMPOSITE LAP JOINTS WITH VARIED BOND QUALITY

R. L. Vijayakumar, M. R. Bhat, and C. R. L. Murthy

Department of Aerospace Engineering, Indian Institute of Science, Bangalore-560012, India

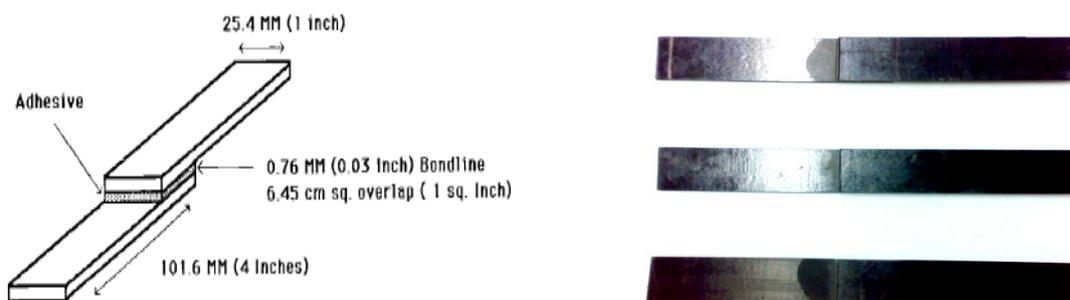
FIGURE 1. CFRP single lap shear joints.

Bonding was accomplished using a two part epoxy adhesive system; Araldite AV 138M/Hardener HV 998. Adhesive to hardener weight ratio was maintained as 100:40 as per the recommendation of the manufacturer. An area of 25.4mm x 25.4mm was bonded and the bond line thickness was maintained at 0.76mm using a specially designed mold which also helps in maintaining a proper alignment of the CFRP adherend strips during the process of curing. The quality of adhesive was varied using different quantities of poly vinyl alcohol (PVA). This releasing agent does not stick to the epoxy and affects the polymerization process, leading to weak adhesion and cohesion. Five sets of specimen, six samples in each were prepared. The set without any PVA content was presumed as healthy denoted by the symbol 'H', the remaining samples were represented by the symbol 'P'. The PVA content was varied from 10% to 40% by total weight of the resin system with an increment of 10% in each set. The adhesive in the joint was cured at room temperature for 24 hours at atmospheric pressure.

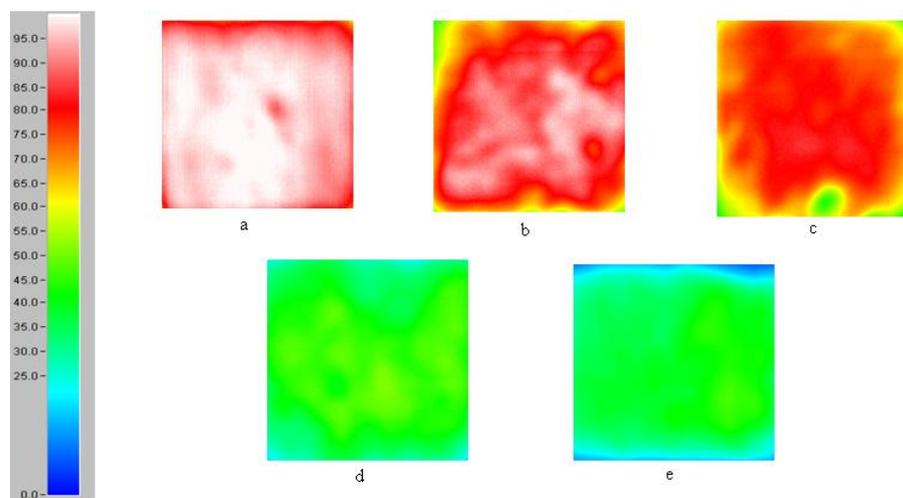
FIGURE 2. Ultrasonic through transmission images for a) Healthy specimen b) 10 % PVA (c) 20% PVA (d) 30%PVA (e) 40% PVA samples.

Inspection of the bonded region was performed by using two coaxially aligned 13 mm diameter, 5MHz focused probes with a focal length of 76mm in water. One of the probes (pulser) generate the ultrasonic energy which passes through the specimen, while the other receives (receiver) the transmitted energy across the bonded region. A rectangular pulse, 72ns wide with a pulse repetition frequency of 1000Hz and amplitude of 350 volts was used to excite the pulser, while the receiver had a gain of 8dB arrived at after trial and error method to obtain a clear transmitted signal. The entire arrangement of probes and the specimen was immersed in water which acts as a medium for acoustic wave propagation. The edges of the joints were completely sealed to prevent the ingress of water into the joint area. The amplitude variation of received ultrasonic signal over the bonded area was mapped to obtain a C-scan (Fig.2) which can give a measure of the adhesive quality in the bond line. The average amplitude for each image was computed using an image processing tool and a plot of normalized amplitude versus PVA percentage was plotted as shown in the Fig. 3. During the curing process the adhesive passes from a semi solid to solid state by the formation of intermolecular bonds, with subsequent creation of the branched chains of molecules which give the adhesive its strength. It is therefore logical to think that; the more developed the polymerization process; the smaller is the attenuation of the ultrasonic wave passing through what is now a more elastic medium with lower energy dispersion. Consequently the amount of ultrasonic energy passing through the healthy adhesive joint is much higher owing to less attenuation. Whereas the joints with added PVA suffer from hampered polymerization and leads to more attenuation of ultrasonic energy.

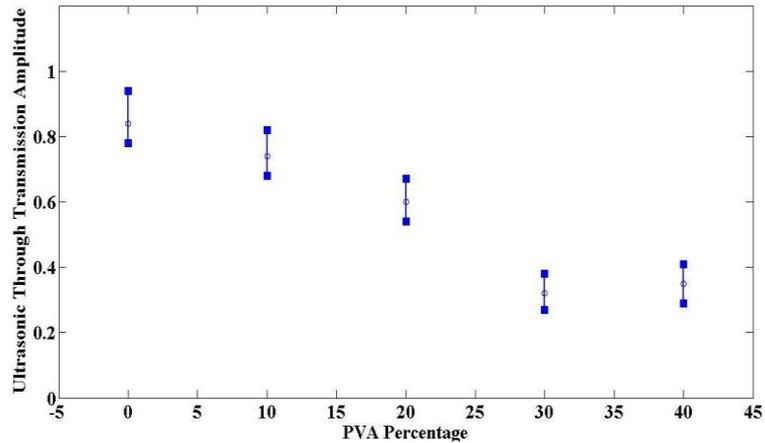
FIGURE 3. Variation of ultrasonic through transmission amplitude with different PVA percentages.

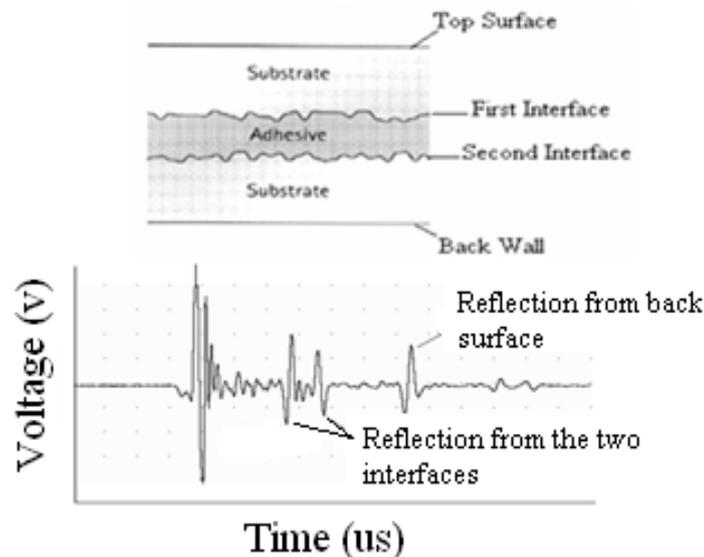
FIGURE 4. Interfaces in an adhesive joint and ultrasonic wave reflections from them.

Unlike through transmission technique, the pulse echo method uses a single transducer to transmit and receive the ultrasonic energy. The adhesive joint is kept normal to the 5 MHz focused transducer and the incident energy gets reflected from the top surface as well as from different interfaces as illustrated in Fig.4

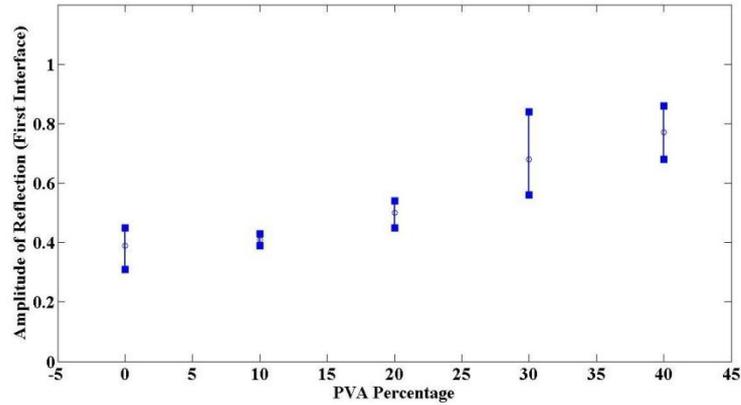
FIGURE 5. Variation of amplitude of reflected signal from the first interface for different samples.

Ultrasonic C scans were obtained for each sample at different interfaces by setting the gate at the corresponding echo, For instance C-scan image for the interface between the top adherend and the adhesive layer was obtained by setting the gate on first interface echo. The amplitude of reflection at the first interface for a healthy joint is lower than those joints having PVA due to better adhesion between the adhesive and the substrate. The amplitude variation for the first interface reflection was computed for different samples and plotted Fig. 5. The amplitude of reflected signal from an interface depends on the acoustic impedance mismatch between the two surfaces, as the amount of PVA is increased the mismatch becomes more predominant; as such higher amplitude reflections are seen. Contradicting this, the quality of adhesion in case of a healthy specimen is better leading to a low impedance mismatch; as such more energy gets transmitted into the bond line.

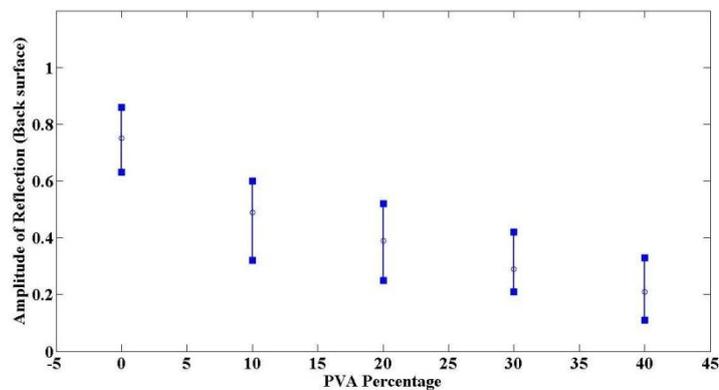
FIGURE 6. Variation of amplitude of reflected signal from the back surface for different samples.

The cumulative effect of all the interfaces can be realized by fixing the gate on back wall echo in the received pulse. It is evident that the amount of energy reaching the back wall depends on the reflection from the first interface, reflection from the second interface and the attenuation of energy by the two substrates and the adhesive in the bond line. Ultrasonic energy reaching the bottom surface of a healthy sample is more owing to weaker reflections and lower attenuation. The variation of amplitude of the back wall echo is plotted against the PVA percentage as shown in Fig. 6

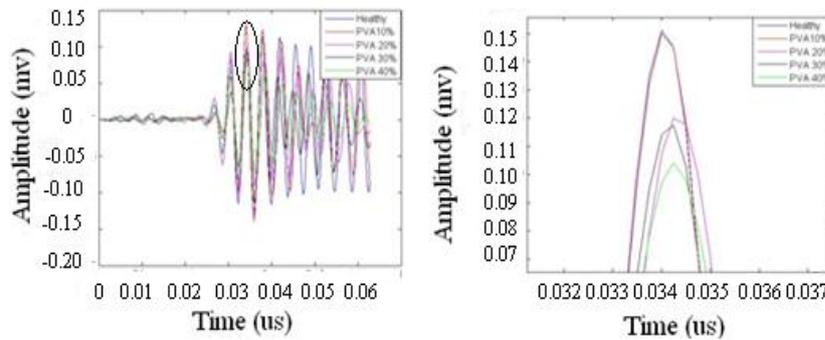
FIGURE 8. Experimental signal received and the magnified view of peaks.

The adhesive joints were also evaluated using lamb wave techniques. To accomplish this two PZT disks were bonded on the either end of the sample as shown in Fig 7. One of the disks acts as actuator (transmitter) while the other receives it. Lamb waves at a frequency of 260 kHz (So mode) was made to propagate through the joint area and the same was received at the other end by the receiver. The received signals were further amplified and processed. Fig. 8 shows the plot of amplitude of the received signal on time axis. It can be seen that the amplitude of a healthy adhesive joint was higher compared to those with different percentages of PVA and the amplitude decreased with increasing percentage of PVA.

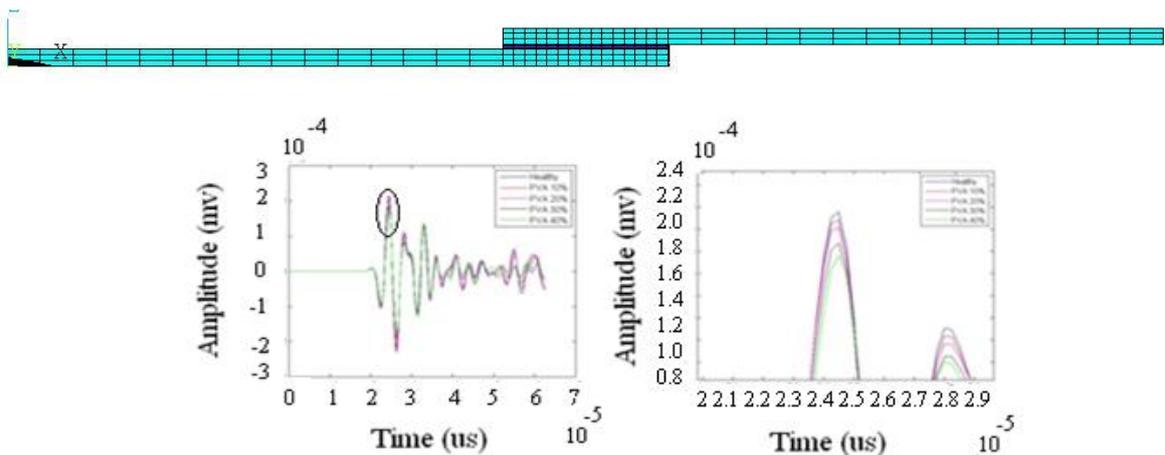
FIGURE 9. Received signal from 2D FEM simulation and the magnified view of peaks.

To validate the experimental results a two-dimensional finite element simulation of the experiment was carried out using ANSYS, a signal similar to that used in experiment was made to propagate through the model and received at the other end. The amplitude of the received pulse was plotted against time and a similar trend was observed (Fig. 9).

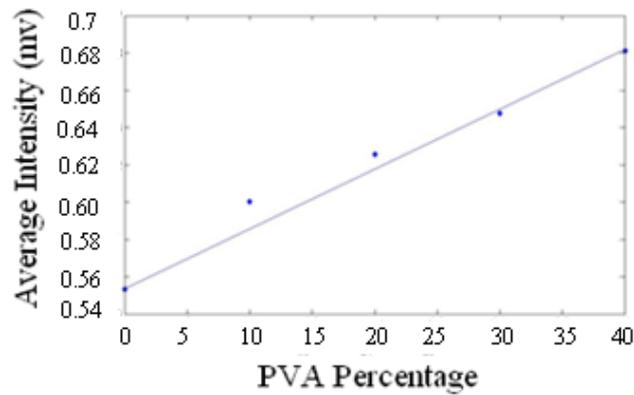
FIGURE 10. Variation of average intensity of X-rays penetrating the adhesive for different samples.

The lap joint CFRP specimens were exposed to low kV X-ray with the plane of the bonded area maintained normal to the X-ray beam. The amorphous silicon flat panel detector converts the transmitted X-rays to light in real time. The intensity of received X-ray energy at the detector depends on three factors - atomic number, density and thickness of the test object. Other two parameters being practically maintained constant, density of adhesive in a healthy sample is higher compared to that in a PVA sample, leading to more absorption of X-rays. Accordingly, the images for healthy samples appear darker. The average intensity of X-rays was plotted for different PVA samples (Fig. 10), it can be seen that the intensity increases with increasing amount of PVA

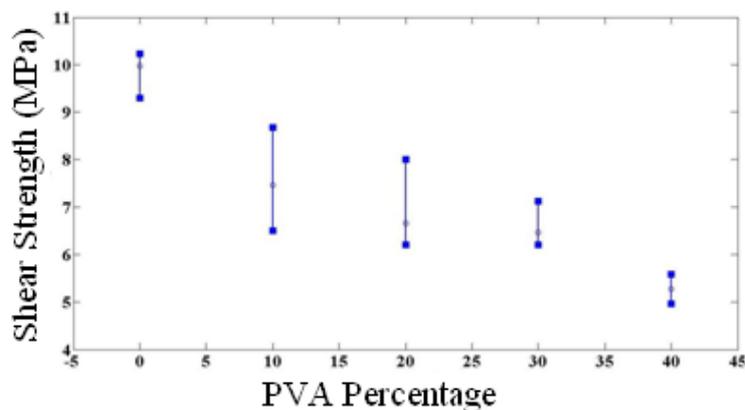
FIGURE 11. Variation of shear strength of adhesive joints for different PVA percentages.

The bonded CFRP samples were subjected to destructive test in an uni-axial loading machine by applying monotonically increasing load till the bonded joints gave away. The failure load for different samples were noted and plotted against the PVA percentage (Fig. 11). It can be seen from the figure that the shear strength of the adhesive joint decreases with increasing orders of PVA. The healthy samples had average shear strength of 10MPa while the joints having 40 percent PVA had an average strength of 5.5MPa. There is a severe degradation of strength for 40 percent PVA samples.
