FROTHS, FIRES AND FIGHTS OVER SUSTAINABILITY OF BELLANDUR LAKE - A CASE FOR INTENSIVE ENVIRONMENTAL DETECTIVISM

Reshmi Das, L.N. Rao, B.S. Jai Prakash and Hoysall Chanakya

*Centre for Sustainable Technologies, Indian Institute of Science Bangalore and 2-ACHMM, Bangalore
Chapter, India*

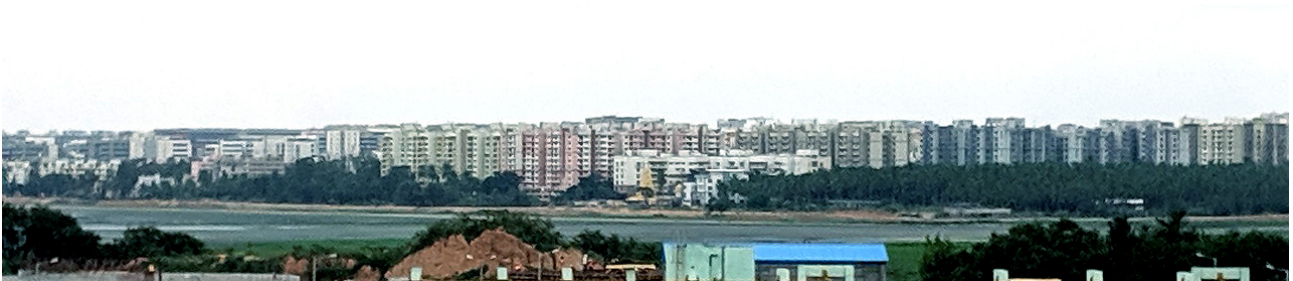
Figure 1: Bellandur Lake skyline showing some of the most intensely populated and built up area. The view shows about a quarter of the shoreline only. At this time the water of the lake in the foreground is drained to clean it up.

Another interesting and intriguing part of the Lake's being is the frequent fire that occurs on the Lake itself. Ironically, the floating macrophytes and dry grass on the banks tend to catch fire during the dry months that could range from early spring (January) to late summer (August). Almost every year, as an annual event, the banks with dry grass or the dried and floating macrophytes tend to catch fire. Although the causes of such fires are difficult to pin-point or forecast, the inaccessibility of the burning parts in the Lake or the dry grass banks makes fire control quite challenging. As a result, the fires can continue burning for periods between 8-30hours. With the long shoreline densely built up as seen in Figure 1, it definitely troubles the residents nearby.

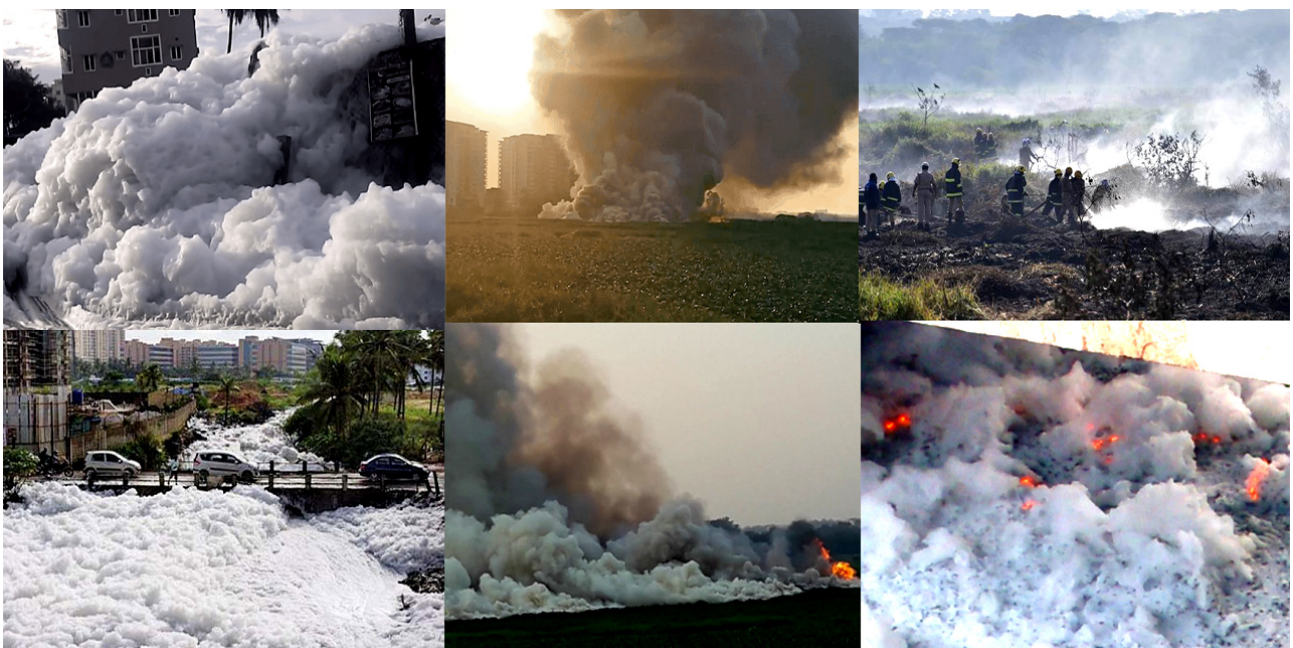
Figure 2: A photo collage showing frothing in the Lake overflowing onto residential areas, foam affecting the traffic, Lake macrophytes on fire (middle) and top right showing firemen extinguishing fire of dry grass on the banks and bottom right showing even the foal having caught fire. Photocollage is made from various internet sources indicated in references and is acknowledged.

Photos in Figure 2 indicates the severity as it often creates obstacle to traffic. It is important to understand that these incidents occur only during periods of high run-off and when the Lake empties itself rapidly over the waste weir or spillway. Another important observation during this period is also that as the water levels rises significantly and the wind blows in the direction of the spillway, firstly a large part of the floating macrophytes also disgorged over the spill way and the lake water surface gradually becomes devoid of the floating macrophyte cover. Second, due to the high velocity winds and high inflows a large part of the settled sludge is also rendered afloat and is rapidly pushed over the spillway. This way the lake become free of a large area of macrophyte cover and also much of the sludge that is accumulated through the year. The role of the sludge being washed off in the phenomenon of foam production is not clear, although there is enough evidence to suggest that a lot of detergents tend to bind to sludge and settle down in still waters. Further, the presence of significant levels of algal population in water and their contribution to foam formation is still not clear [Mahapatra et al, 2012].

This foam formation during high run-off periods is seen as a nuisance and it generally becomes newsworthy only when the foam occupies a significant part of the road downstream of the Lake and blinds traffic. Needless to state, the foam levels are compounded by the fact that very little of aerobic conditions exists in the lake where there is potential for some of the detergents present in the water to be degraded. During the early years (2006-2016), the foam occurrence was attributed to the high levels of use of phosphatic detergents used by rogue industries and 'cheap' detergents sold by unscrupulous manufacturers. However, after extensive analysis of the P content and the types of detergents found, this theory has generally now received a backseat [Das et al, 2012]. Yet, this foam is labelled toxic and is often reported to cause serious skin allergies and infections. On the other hand, several steps have also been taken up by the City Corporation. Firstly, they have slowed down the fall by creating a ramp. Second, water from the stream is pumped strongly over the foam to break it. Third, the outfall is now changed to a sluice gate that will discharge the outflow water directly to levels of the stream without creating a waterfall and therefore a reason for foam to build up and accumulate. Fourth, a tall netting is provided on the Lake side of the road to arrest the foam.
